PRINCE GEORGE'S COUNTY  
HISTORIC SITE SUMMARY SHEET

Survey #: P.G. #82A-36 Building Date: ca. 1905  
Building Name: Douglas House  
Location: 10301 Old Indian Head Road, Upper Marlboro, Maryland  
Private/Residence/Occupied/Good/Inaccessible

## State Historic Sites Inventory Form

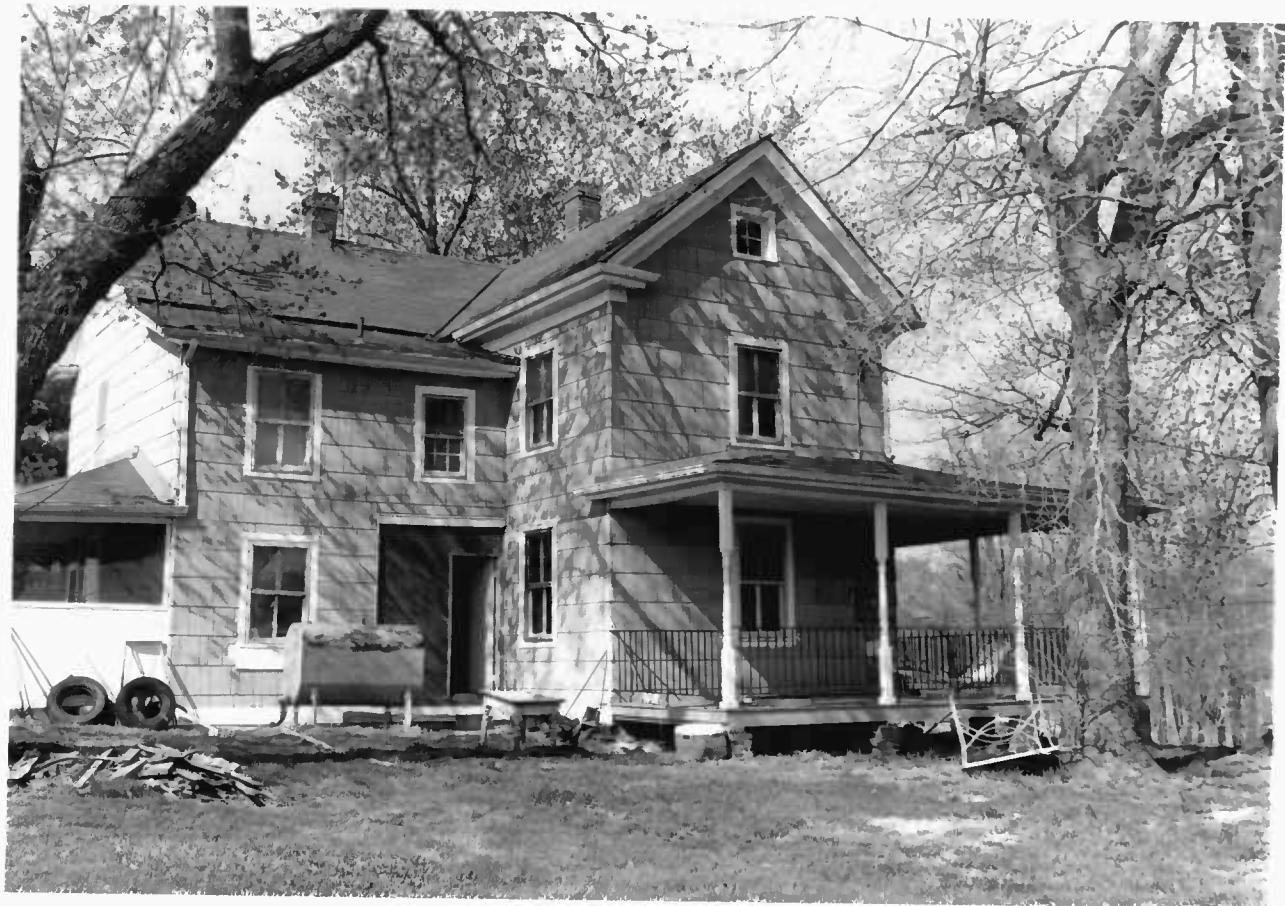
PG#82A-36

Douglas-Reamy House  
Prince George's County, MD  
Susan G. Pearl  
April 1986  
South elevation  
Neg: Md. Hist. Trust, Annapolis, MD

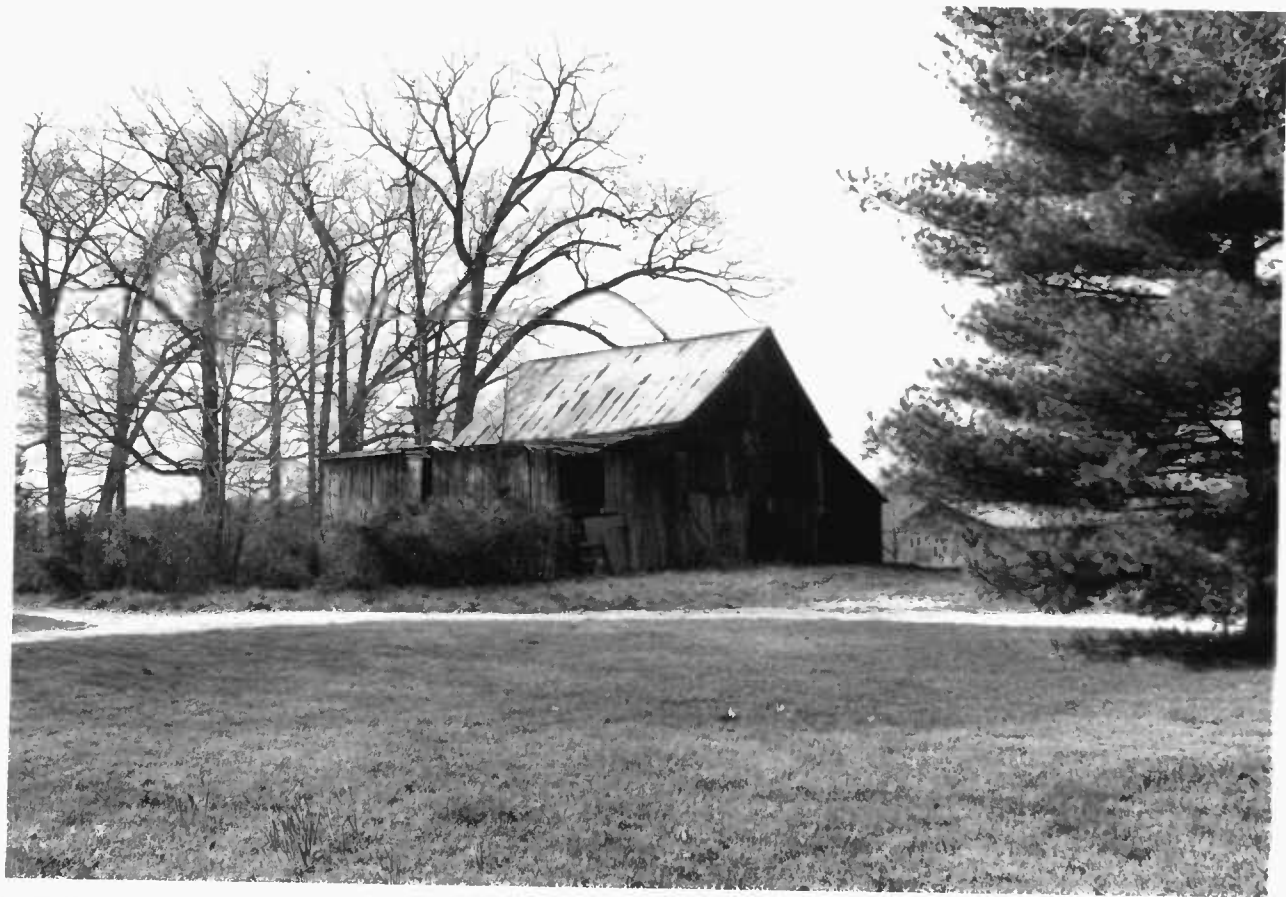
PG#82A-36

A short distance northwest of the house, on the other side of the unpaved farm lane, is a gable roof barn with vertical board siding; it has a lean-to wing on each side, and its roof is covered with standing seam tin.

Douglas-Reamy House  
Prince George's County, MD  
Susan G. Pearl  
April 1986  
Barn, view to northwest  
Neg: Md. Hist. Trust, Annapolis, MD

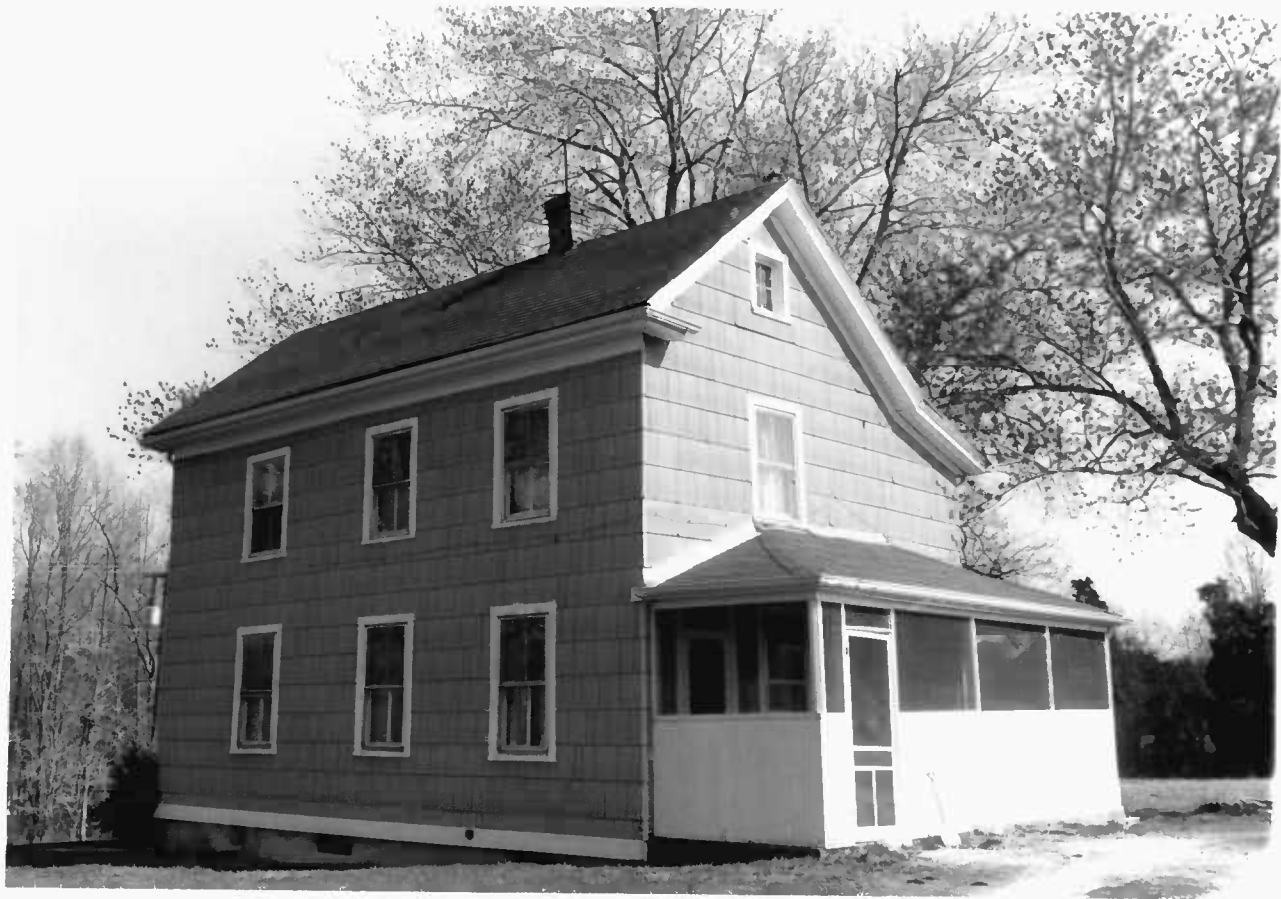
PG#82A-36

There are two additions in the rear of the house. A lower two-story shed addition extends the westerly wing one bay to the south; across its widened west gable end is a one-story hip-roof, screen-enclosed porch which shelters a rear entrance in the first bay of this west gable end. The entrance has a single-pane transom.

Douglas-Reamy House  
Prince George's county, MD  
Susan G. Pearl  
April 1986  
Northwest 3/4 elevation  
Neg: Md. Hist. Trust, Annapolis, MD

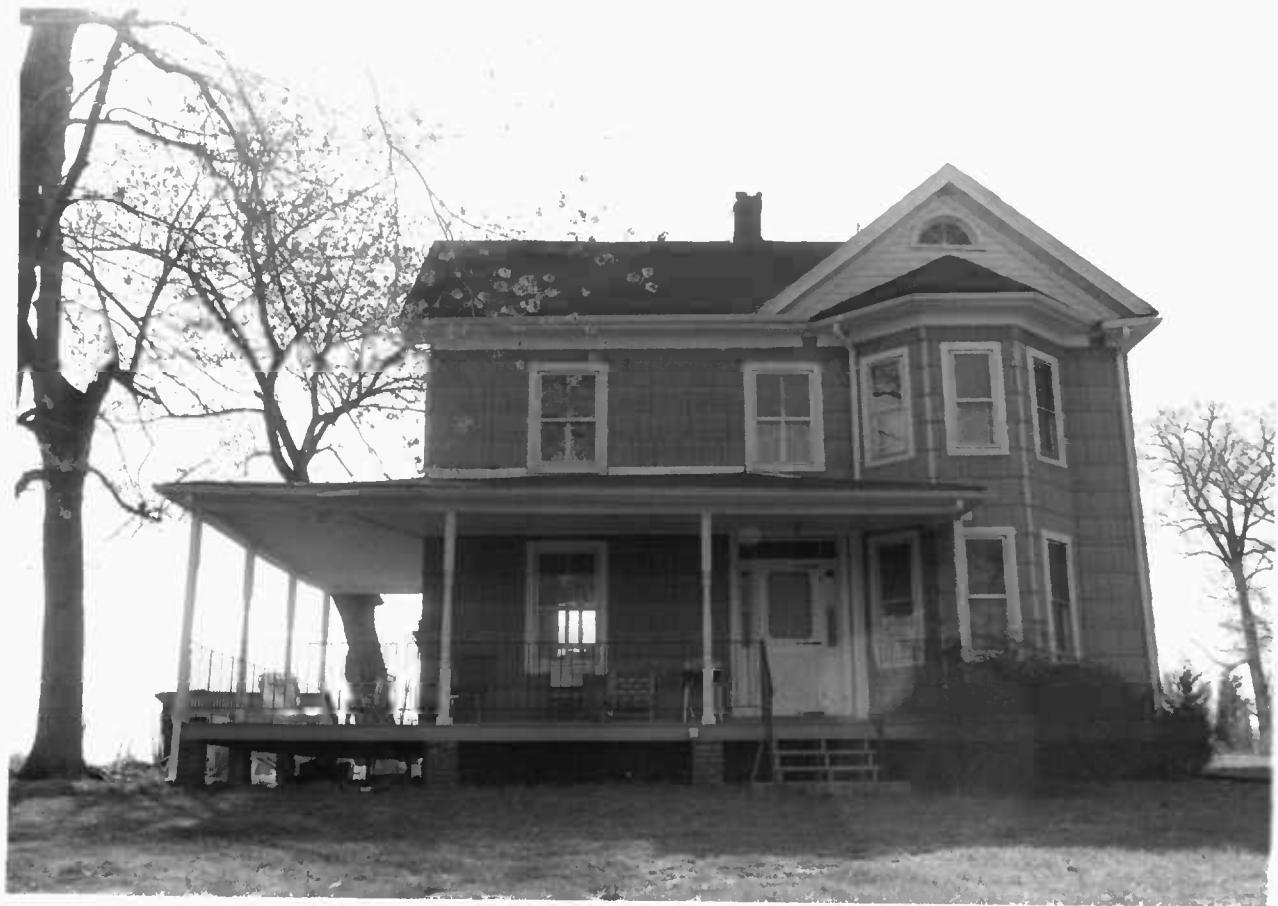
PG#82A-36

The principal east facade consists of a one-bay-by-three-bay front gabled section on the north which is highlighted by a two-story projecting semi-octagonal bay; the bay has a three-plane hip roof and molded cornice, and there are 1/1 double hung sash windows in each of its three faces. Above the roof of the projecting bay in the gable end is a four-section lunette window; the gable end at this level is covered with German siding painted white.

A one-bay-by-two-bay wing extends south from and flush with the principal east gable end. Entrance is in the second bay of its two-bay east facade through a four-panel door. The entrance has three-pane transom and two-pane sidelights, and a plain board surround. A one-story hip-roof porch shelters the door, and continues south to wrap around the south gable end. The porch is supported by turned posts and rests on brick piers; a metal railing has recently been added.

Douglas-Reamy House  
Prince George's County, MD  
Susan G. Pearl  
April 1986  
East elevation  
Neg: Md. Hist. Trust, Annapolis, MD
